MAPLE CREEK EMERGENCY CULVERT REPLACEMENT

TRANSPORTATION CATEGORY

The Junction Dam is located approximately eight (8) km north of the Town of Maple Creek, Saskatchewan. In 2008, the Junction Dam was reconstructed to include a free-overflow labyrinth weir structure (Labyrinth Spillway) to handle increased flood waters and reduce operating risks during run-off events. The auxiliary spillway is located approximately one (1) km east of Maple Creek.

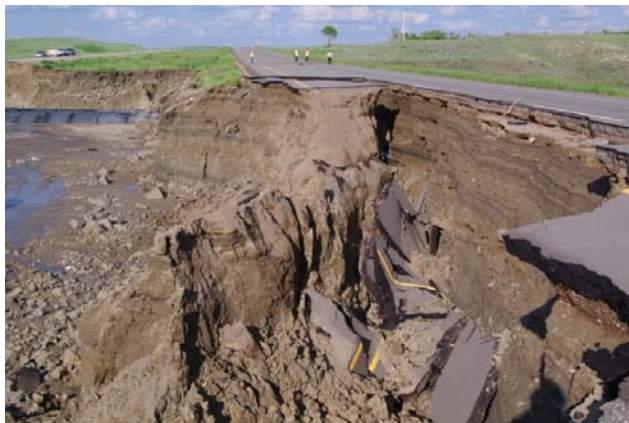
Figure 2 – Remaining eastbound lanes, looking east.

MDH personnel arrived at the washout site on 20 June 2010 at 10:30 am. The Saskatchewan Ministry of Highways and Infrastructure's (SMHI) significant initial concerns included potentially losing the remaining eastbound lanes due to a piping failure from seepage and the uncertain stability of the vertical face. Losing the remaining eastbound lanes would have forced traffic to remain on the five hour detour for several months.

Emergency repairs began immediately to stabilize and restore the eastbound lanes and construct temporary traffic transitions to allow two-way traffic on the eastbound lanes. Construction began by excavating the washout area on 21 June 2011 and hauling 41,000 tonnes of granular material to the washout site from a SMHI aggregate source using a combination of SMHI and private trucks.

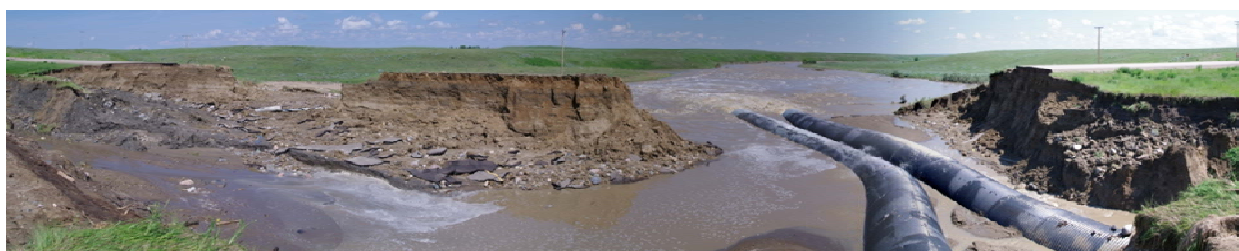
In 2010, increased spring runoff combined with heavy precipitation in April and May filled the water storage reservoirs in the area of the Junction Dam. Over 100 mm of rain fell on the Maple Creek drainage basin over the evening of 17 June 2010 through to 18 June 2010. The peak inflow to the Junction Reservoir occurred at 12:00 am and was categorized as a 1:3300 year event. The heavy rain fall caused the outflows from Maple Creek to exceed the capacity of the existing two (2) 3.6 m corrugated multiplate culverts under Trans-Canada Highway. The water consequently overtopped the Trans-Canada Highway (Highway No. 1) on 19 June 2010 at 1:50 am. Approximately 100 m of the westbound lanes of the Trans-Canada Highway washed out by 4:50 am, with damage also occurring to 200 m of the eastbound lanes, leaving an 11 m high crater around the culvert location (Figure 2 and Figure 3). The Trans-Canada Highway near Maple Creek generally handles approximately 4,700 vehicles per day, with approximately 33 per cent being heavy truck

Figure 3 – Damaged roadways and culverts, looking north.

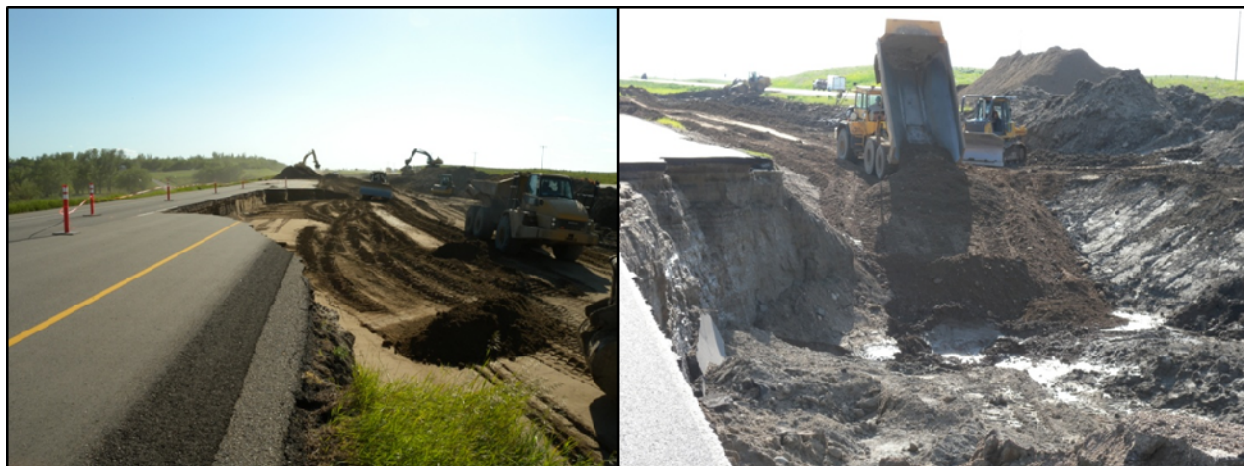
Figure 4 – Placing granular material.

The material was placed against the eastbound lanes (Figure 4). The placement of granular material was completed in three (3) days. Erosion control material was installed to protect the granular material. The

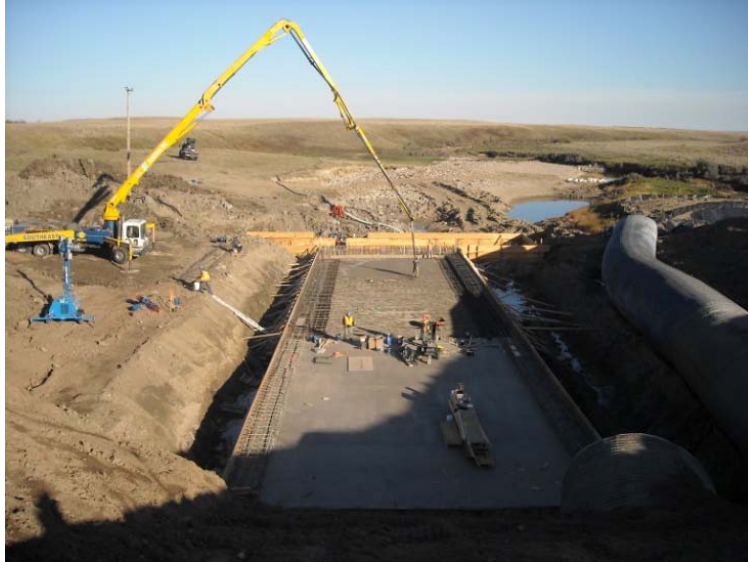
Figure 5 – Concrete pour for raft slab foundation.

Construction began on 13 September 2010 with isolation of the channel and a fish salvage, which collected over 80,000 fish. Construction of the arch culvert included the following: removal of a section of the west culvert, excavation for the raft slab under the culvert, forming and placement of reinforcing steel for the raft slab and tail wall areas, three separate pours of concrete totaling 1,350 m³ (Figure 5), constructing concrete

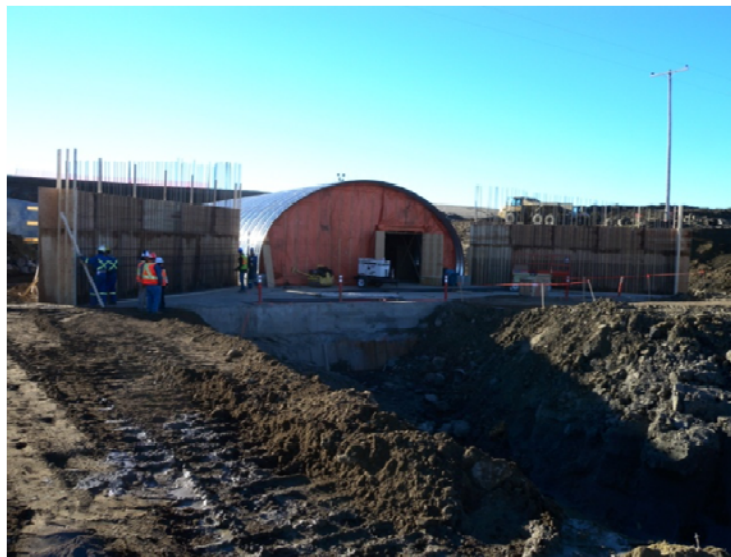
Figure 6 – Hoarding the culvert to prepare for granular backfill placement in winter conditions.

The arch culvert was not completed until late October 2010, so the granular backfill around the culvert was completed primarily in freezing conditions. The contractor hoarded the arch culvert and used heaters to keep the granular material from freezing (Figure 6 and Figure 7). As it got colder, insulated tarps and heaters were used to cover the granular material in the stockpile and around the culvert.

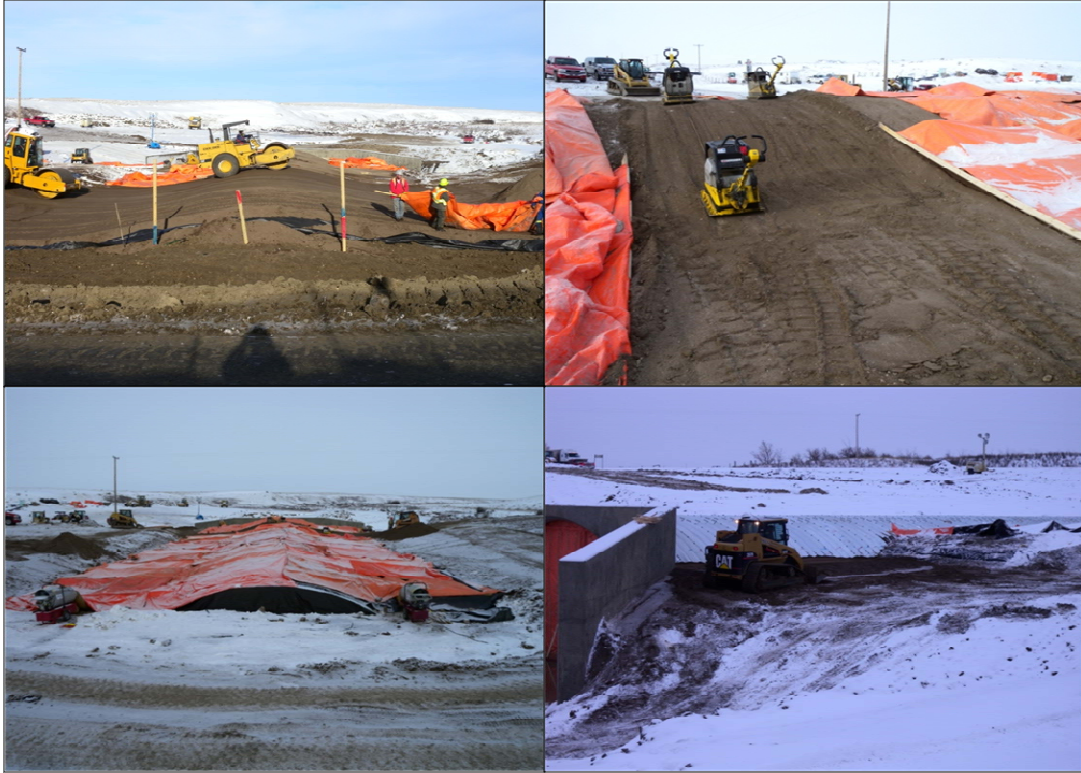
Figure 7 – Backfilling granular material in winter conditions.

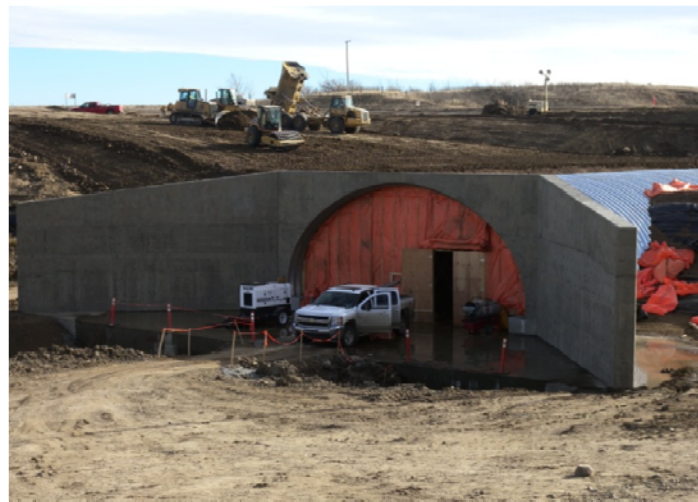
Figure 8 – Geosynthetically confined soil wall behind wingwall.

When it appeared that the downstream wingwalls would not be constructed in time to contain the granular backfill around the culvert, MDH designed a geosynthetically reinforced soil wall at the north end of the granular backfill, so that the embankment could be built at the same time as the wingwalls (Figure 8). This was necessary as the roadway embankment was on the critical path for opening the four lane facility in December 2010.

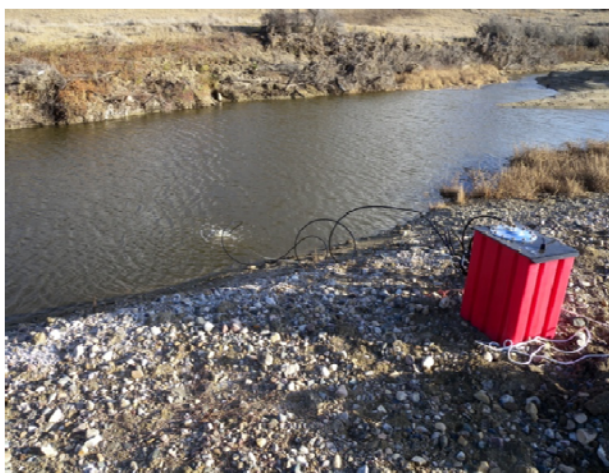
Figure 9 – Aeration system to prevent ice forming in temporary fish habitat.

As part of the 2010 construction, DFO required excavating restoring a 6 m deep scour hole at the culvert outlets that had been filled with sediment during the flood. In November 2010, the scour hole was constructed to provide a safe winter habitat for the fish in Maple Creek. Due to consistent freezing temperatures, an aeration system was installed to provide oxygen and prevent ice from forming in the temporary habitat (Figure 9) until salvaged fish could be relocated to a permanent winter habitat downstream of the construction zone. Riparian works opened upstream of the arch culvert in December 2010 to flood the construction area and the scour hole before removing the coffer dam and allowing the salvaged fish to swim to their permanent winter habitat.

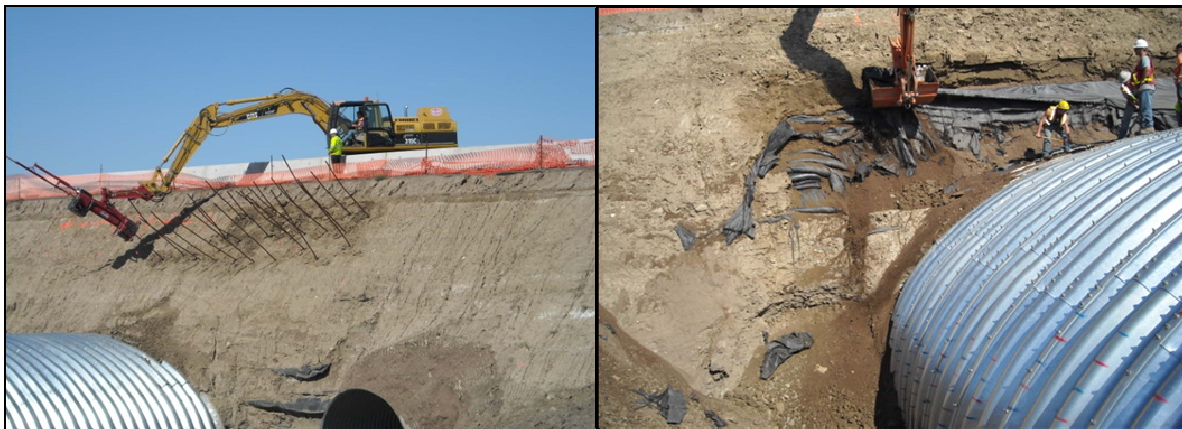
Additional complications arose in 2011 when the Contractor was unable to connect the arch culvert to the section built in 2010 because three of the arch culvert panels on the east side were deformed. This was caused by differential loading against an unsupported edge when the culvert was back filled in 2010. The only way to align the culverts was to unload the panels, so they could be removed and replaced. Unloading the panels carried a unique level of complexity and risk because an 11 m high almost vertical face already existed immediately adjacent to traffic. Additional excavation of this face was required to unload the arch culvert panels, so that they could be repaired. In order to carry out work in a manner that ensured safety for the workers and motoring public, air launched soil nails were installed to increase the geotechnical factor of safety and mitigate the risk of catastrophic slope failure (Figure 10). The contractor also placed granular back fill around the rest of the south half of the culvert to provide more stability. The arch culvert repair and granular back fill was completed as quickly as possible to mitigate the potential risk.

Figure 10 – Installing soil nails to strengthen westbound lanes for excavation around 2010 arch culvert construction.

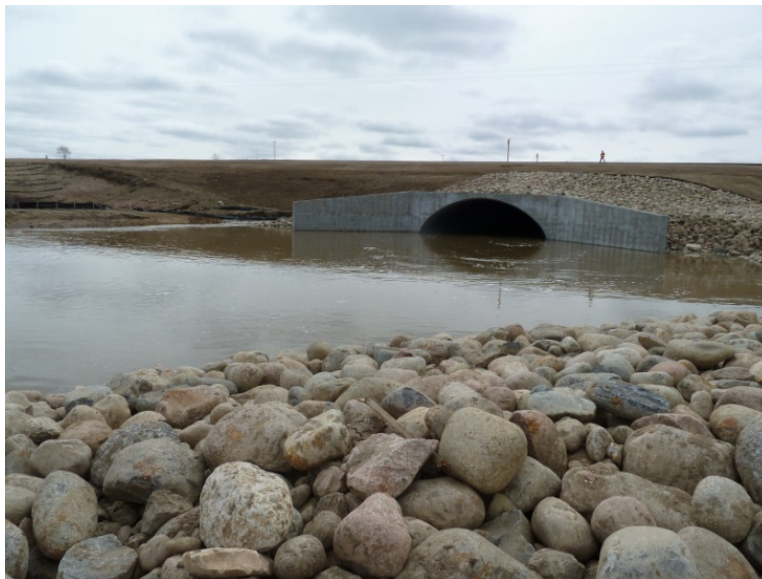
Figure 11 – Completed culvert and riprap December 2010.

The construction of the Trans-Canada Highway Maple Creek Arch Culvert (Figure 11), highway construction and the channel/riffle system was completed on 27 October 2011 with four lane traffic opening to the public later that day.
